<b>QUALITY ALERT HR.0001</b>
------------------------------

**Title:** Electronics Cover - 28990

**Part Number:** 28990

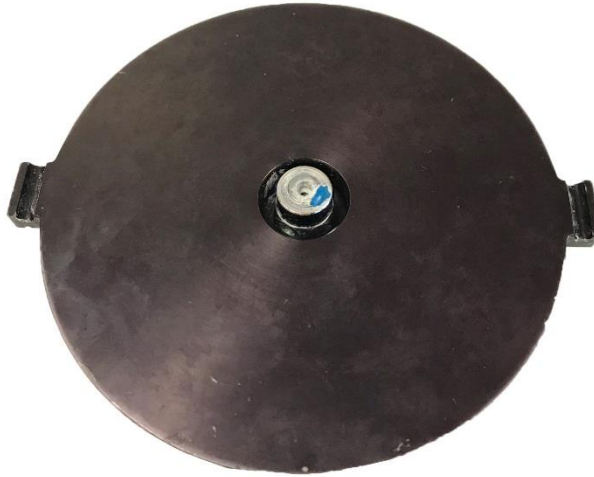
**1. Remove Old Battery Cover**

- a. Unhook both latches and remove old aluminum battery cover

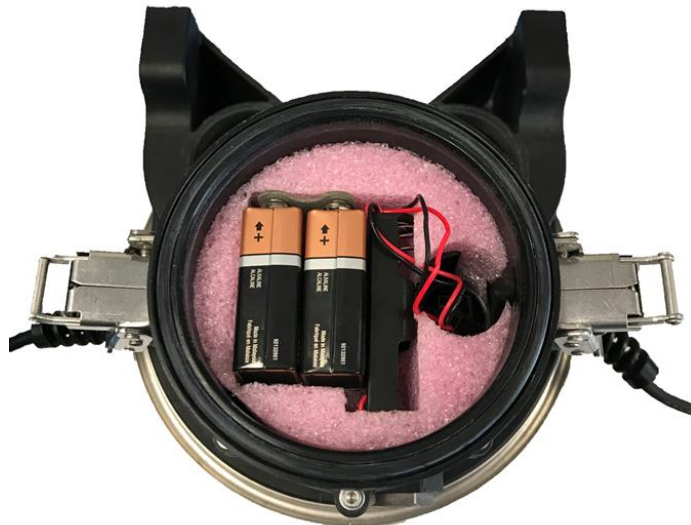
**2. Inspect Battery Compartment**

- a. Clean and lubricate O-ring if necessary
- b. Check for moisture inside battery compartment. If moisture is found, **DO NOT DIVE**  
Please contact Hollis Rebreathers customer support for factory inspection immediately
- c. Check contacts on 9V and 3.6V Lithium batteries inside battery compartment, ensure they are charged and replace if necessary

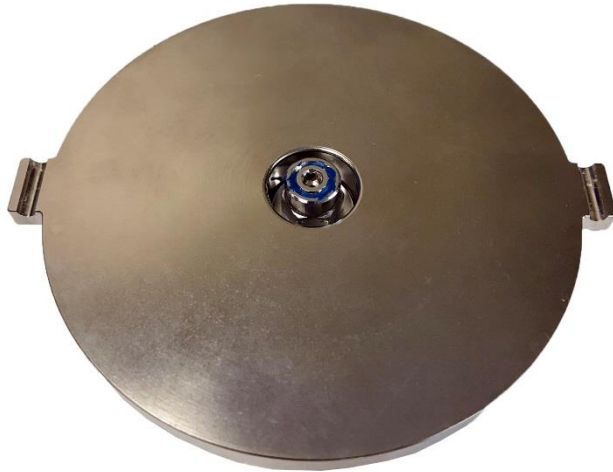
**3. Install New Stainless Battery Cover - 28990S.A**

- a. Secure both latches and ensure battery cover is seated properly
- b. Your Prism 2 electronics cover is now upgraded
- c. If you have any additional questions or concerns, please contact [service@hollisrebreathers.com](mailto:service@hollisrebreathers.com) or call 385.770.7430
